# **BORESAVER ULTRA C**

Case Study 004 Mansfield, Texas January 23-24, 2012

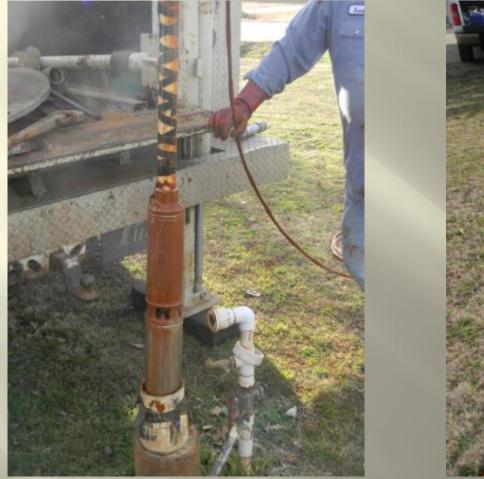
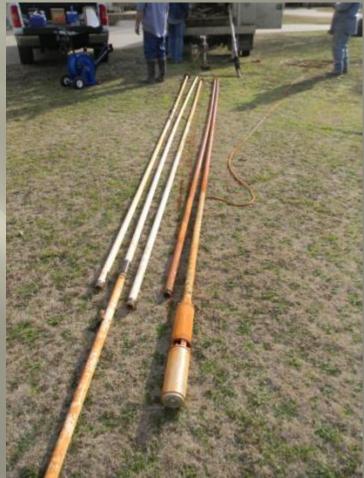
We were going to use the bailer as a block to knock off debris before we brushed, but we figured the pump already did that when we pulled it out of the 4" hole. Here you can see how bad the iron problem is on the pump and the drop pipe.

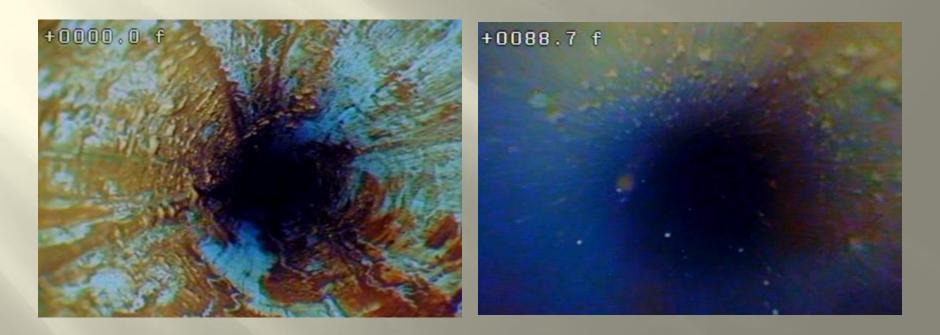
The pipe above the static water line was stained from the IRB, and as soon as the camera went under water, large globules of iron bio film were so prevalent it was hard to find a spot where a picture could represent what we were seeing.

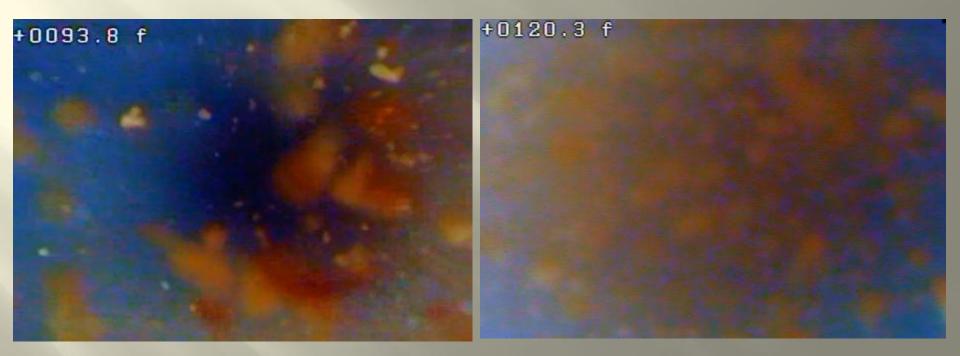
The bio film was so thick that all we could see in the side view was iron bacteria bio-mass (debris and bio film falling past the camera), and the down view was just glob after glob of IRB all the way to the bottom.

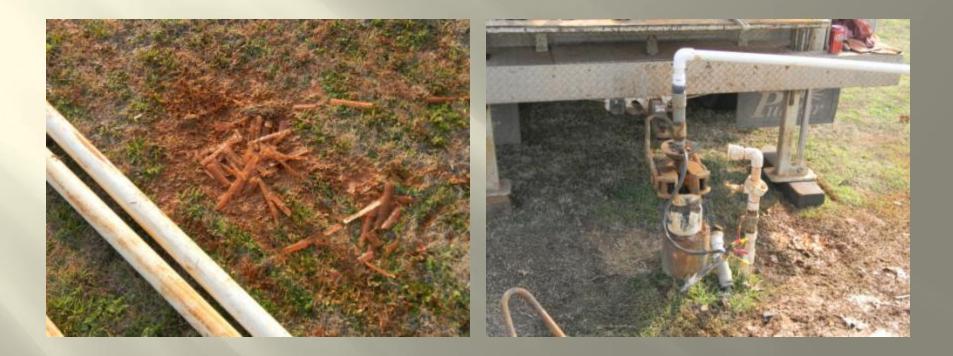
As we picked up the drop pipe, frozen pieces of reddish-brown ice fell out of them. We hooked up the pump so that we could pump to waste.

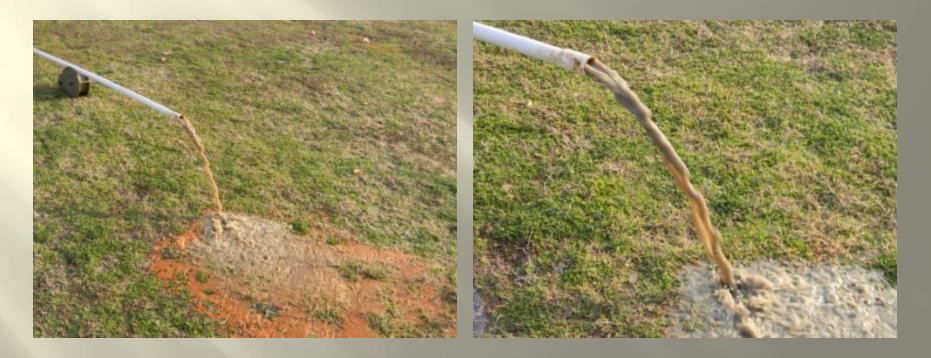
When we first started pumping out the hole, the water came out reddish-brown, but after a few minutes, it turned to a grayish-brown color. We tested the acidity at this point and it was about 6.0

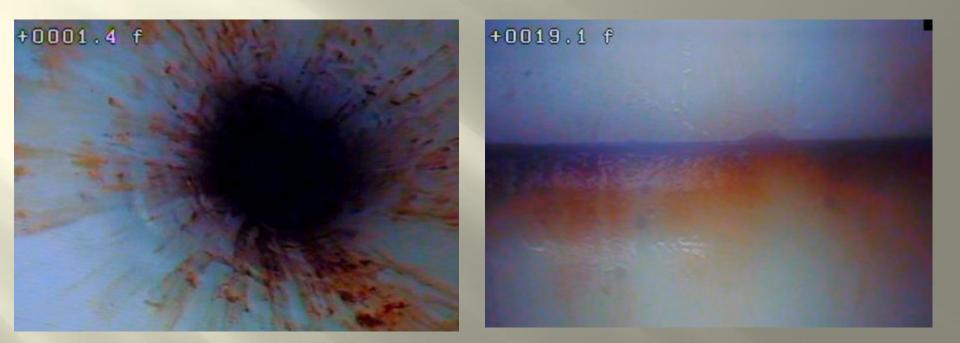
Even though we weren't under water at this point, it was obvious from the first look that things had changed down hole. Yesterday this PVC was so covered you couldn't see anything but orange stain at this point

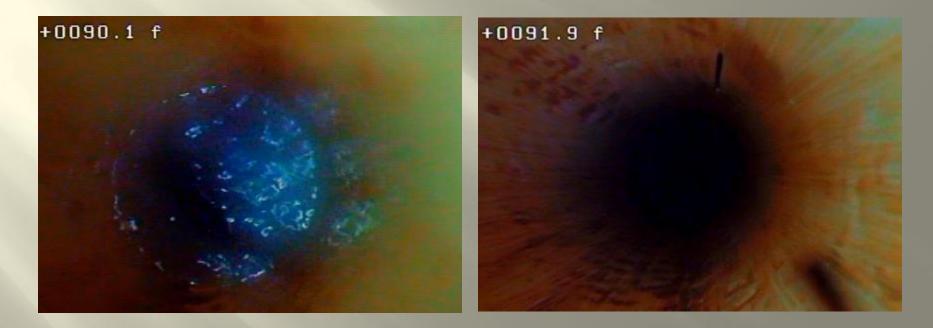
Due to our pumping, the water level had dropped about 3 feet. But as soon as the camera went underwater, everyone was shocked to see how clear the water was. Immediately we noticed we could see the cut perforations in the PVC casing.

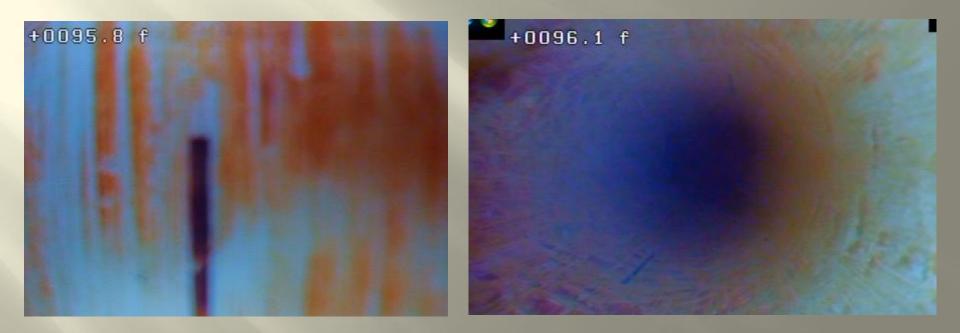
Not only could we see the slots, but we could see the slots were open.

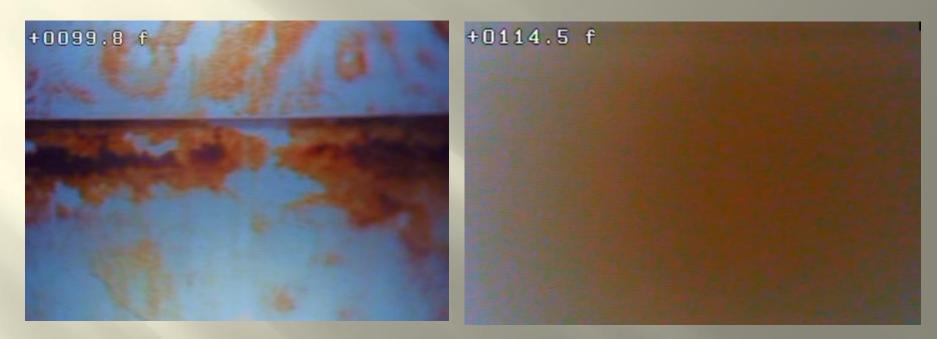
Everything above where the pump was set was 100% clear. We never saw any floating bio-film in any place in the well. Once we got below where the pump was set, the water was too murky to see anything in either down view or side view. We recommended bailing this portion of the hole out later. This is a good example of what Boresaver Ultra C does. It breaks down Iron Related Bacteria and holds it in solution for you to pump it out. In this case, we pumped out everything that was above where the pump was set. But below the pump will need to be bailed out.

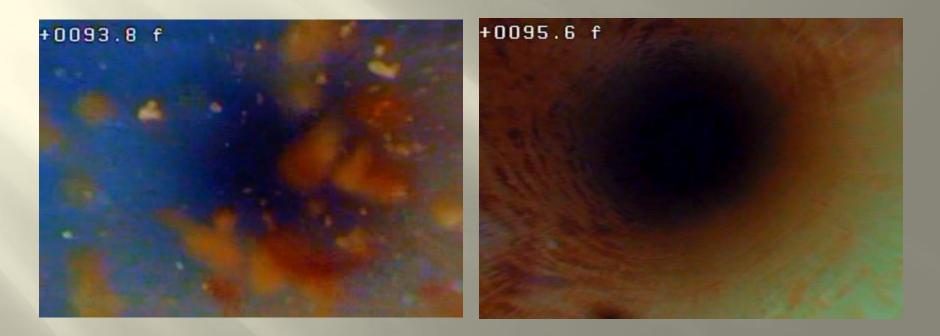
Before and After: Basically the same place in the hole one day before and one day after treatment.

- Original specific capacity when drilled was 15 GPM
- After standard acid treatments, specific capacity returned to only 7-8 GPM
- After Boresaver Ultra C treatment, specific capacity was again measured at 15 GPM
- Water color was clear, but some iron could be tasted in the pumped out water.
