# **BORESAVER ULTRA C**

Case Study 004 Mansfield, Texas January 23-24, 2012

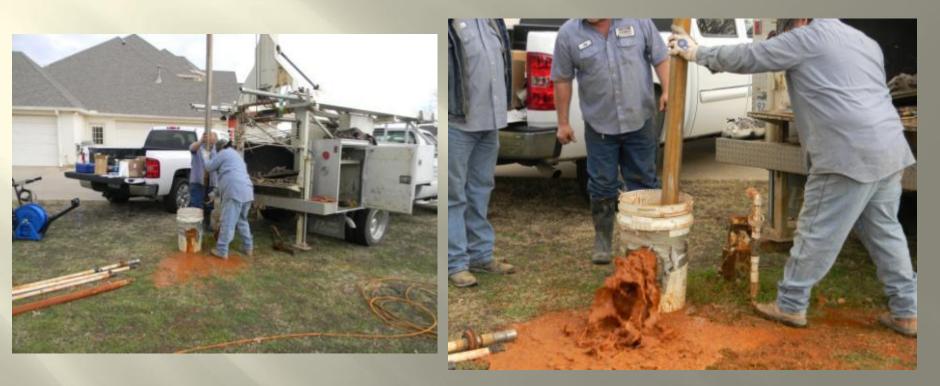
The bio film was so thick that all we could see in the side view was iron bacteria bio-mass (debris and bio film falling past the camera), and the down view was just glob after glob of IRB all the way to the bottom.

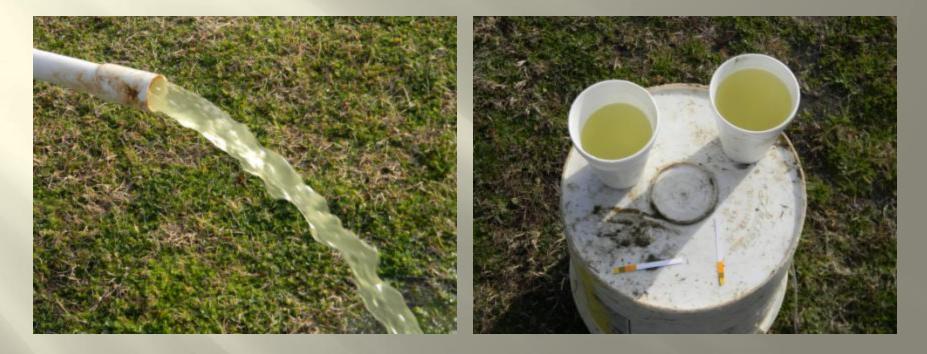
When we first started pumping out the hole, the water came out reddish-brown, but after a few minutes, it turned to a grayish-brown color. We tested the acidity at this point and it was about 6.0

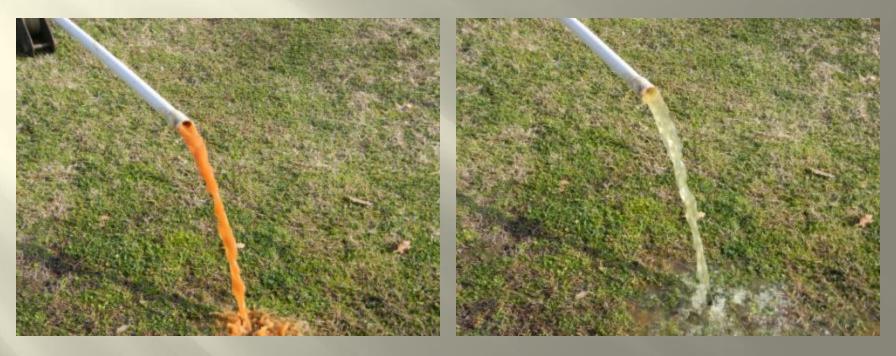
After nearly 30 minutes of pumping, the color started staying a consistent green. We charted the change in color from time to time. By the time it reached this color, the ph level was never less than 7.0

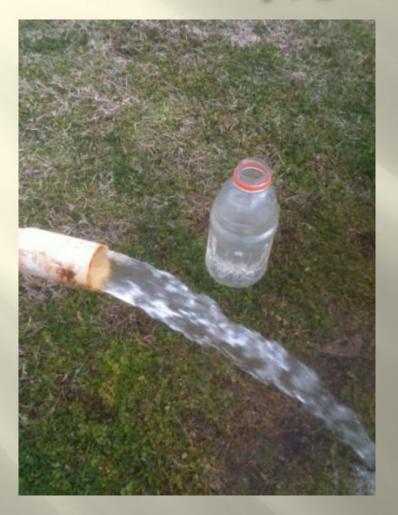
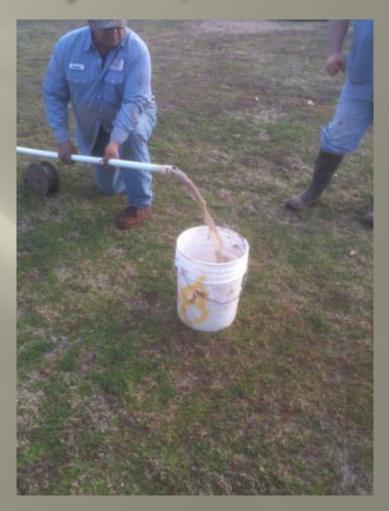
After surging for over 2 hours, we let the pump run untouched for one hour. After a total of 4 ½ hours pumping, the water was clear. This well had never had clear water before. The driller was so overcome, he bent down and drank some! He said he could still taste iron in it – but no one could see iron anymore.

The water came out clear... and at 15 GPM
